Slope Erosion Prevention Techniques

A variety of techniques have been applied along Caltrans highways for erosion prevention on adjacent slopes. This bulletin discusses several of the techniques observed by the Post Construction Inspection Team, notes what is working and what has been less successful, and identifies factors beyond the control of erosion management that can affect side slope stability.

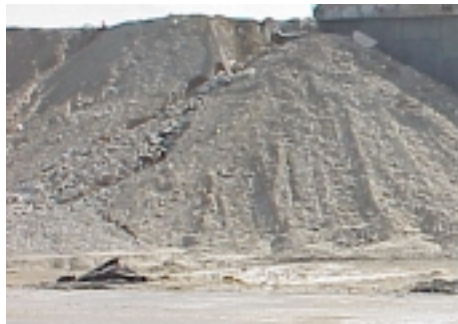
Erosion damage due to untreated slope

Left unchecked, erosion can increase project maintenance requirements, damage project aesthetics, jeopardize the structural integrity of project features, and pose a potential threat to water quality. Erosion control measures, incorporated into the project design or applied as a temporary BMP, minimize the opportunity for erosion impacts to develop.

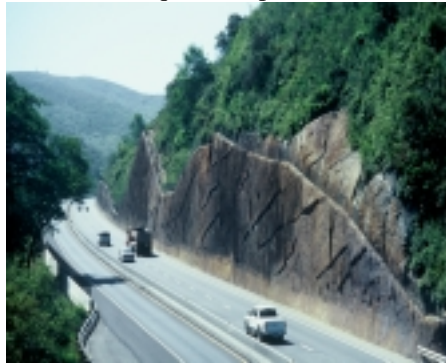
where the roadway design requires a significant cut into an existing hillside and slope lengths or steepness ($>1:1.5$) are too great to deploy surficial erosion control techniques (see photo below).

Retaining wall for slope cut stabilization and top of wall ditch for runoff control

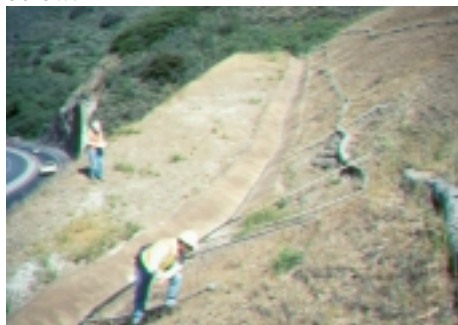
Surficial techniques for erosion control may be used where design slopes are short and sufficiently mild (1:2 or flatter). Surficial techniques include the use of erosion mats or blankets, mulch, silt fences or soil adhesives. Even where structural measures, terrace grading and lined channels have been employed, slope stabilization may require the addition of temporary surficial techniques, such as hydromulch, fiber rolls, concrete ditch and infiltration pipes, as depicted in the photograph below.

Combination of stabilization techniques

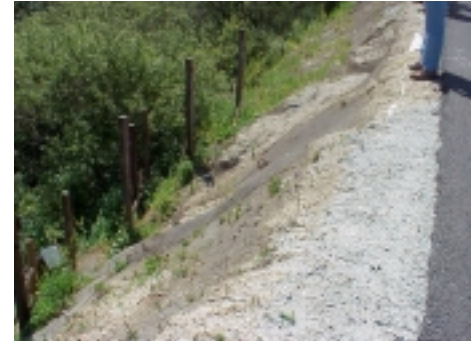
Erosion control measures such as hydroseeding, bonded fiber matrix, rolled plastic sheeting, blankets or geotextiles are not successful in areas where slopes are too steep ($>1:1.5$), or in areas where runoff is not adequately controlled. Surficial techniques cannot be relied upon in areas where flow concentrations or gravitational forces overwhelm the

stabilization effects of the selected product. The Post Construction Inspection Team findings confirm that surficial solutions to roadside erosion problems are only successful when attention has been given to treatment of the underlying grade and control of stormwater runoff.

Soil blanket on a steep hillside with uncontrolled runoff

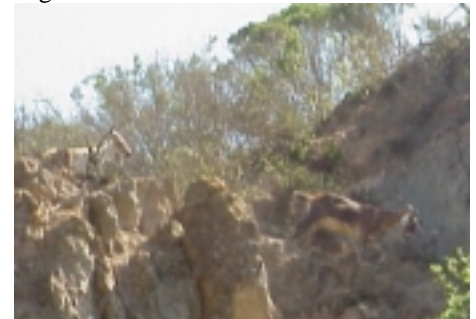
Additional factors can cause hillside soil loss despite the most conscientious application of structural and surficial erosion control measures. General slope failure, due to geotechnical rather than surficial instabilities, can cause "slip failure" of an entire hillside. Unstable soils, improper grading or off-site construction activities could be factors associated with this type of slope failure. In addition, livestock free to wander on properties abutting project right-of-way can seriously impact the effectiveness of vegetative or onsite measures.

Livestock disruption of hillside stability

Thus, erosion control along constructed or modified roadside slopes is one of several factors that must be given serious consideration in the establishment of stable hillsides associated with Caltrans projects.
